Subject: On-Call Asbestos, Lead, Air Quality & Demolition Compliance
Agreement No.: 8.07-01 (18)
HazMat Inspection - Bridge No. 01686B, I-84 TR825 over Route 44 EB & Columbus
Boulevard, Hartford, CT
ConnDOT Assignment No. 514-6288
ConnDOT Project No. 63-654
TRC Project No. 289951.6288.0710

TRC performed a limited survey for hazardous building materials associated with the rehabilitation of Bridge No. 01686B, I-84 TR825 over Route 44 EB & Columbus Boulevard in Hartford, Connecticut. Results of the survey identified lead paint to be present on the structural steel/metal bridge components and railing supports at Bridge No. 01686B. Results obtained from TCLP waste stream sampling and analysis for leachable lead from the paint on the structural steel/metal bridge components and railing supports characterized the paint waste streams at Bridge No. 01686B as CTDEEP/RCRA hazardous waste. No detectable amounts of lead in paint were identified on the small yellow painted section of Pier No. 6, therefore any project paint waste stream would be non-hazardous, non-RCRA lead waste. Black tar between the expansion joints beneath the bridge were sampled and found to contain asbestos. Canvas betwee

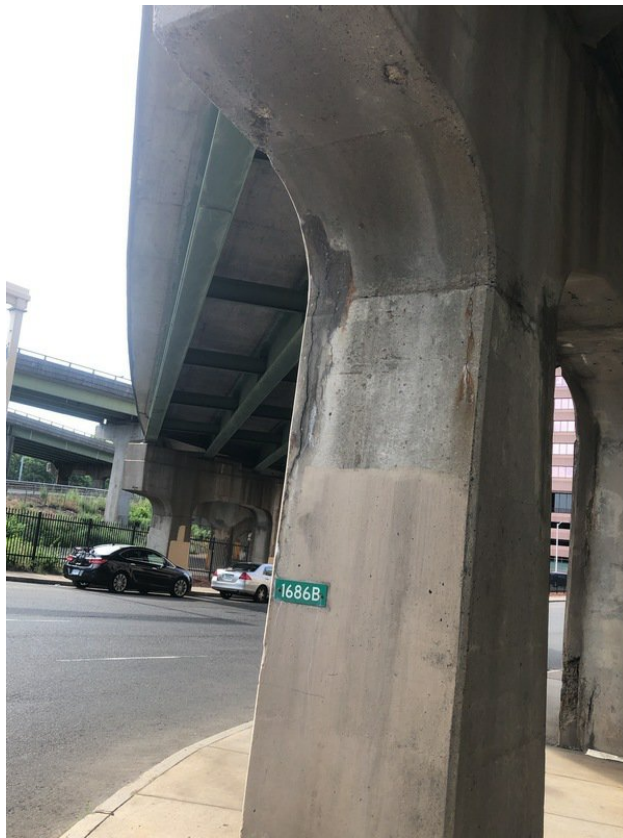
Pier 2 w/ bridge number

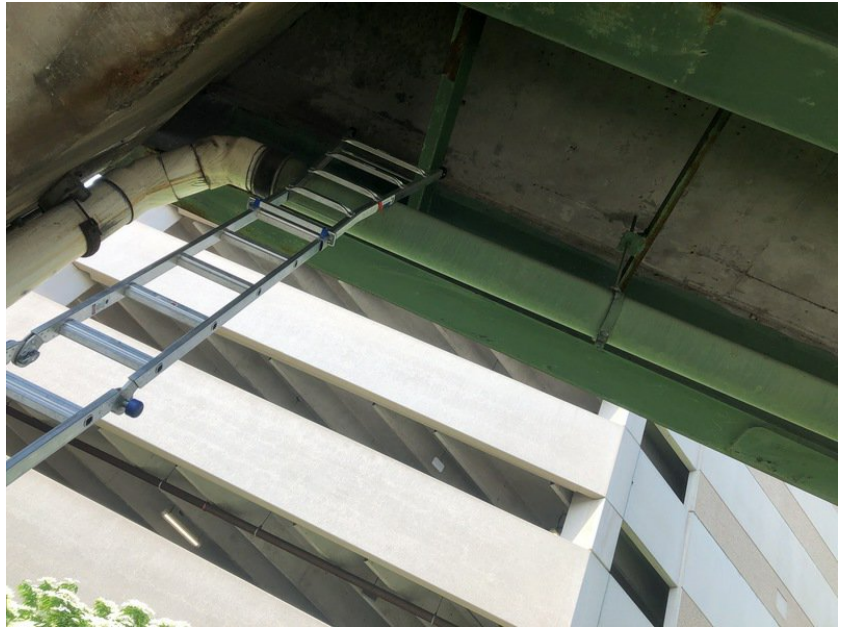
Pipe between pier 1 and 2. The pipe is ~50 LF.

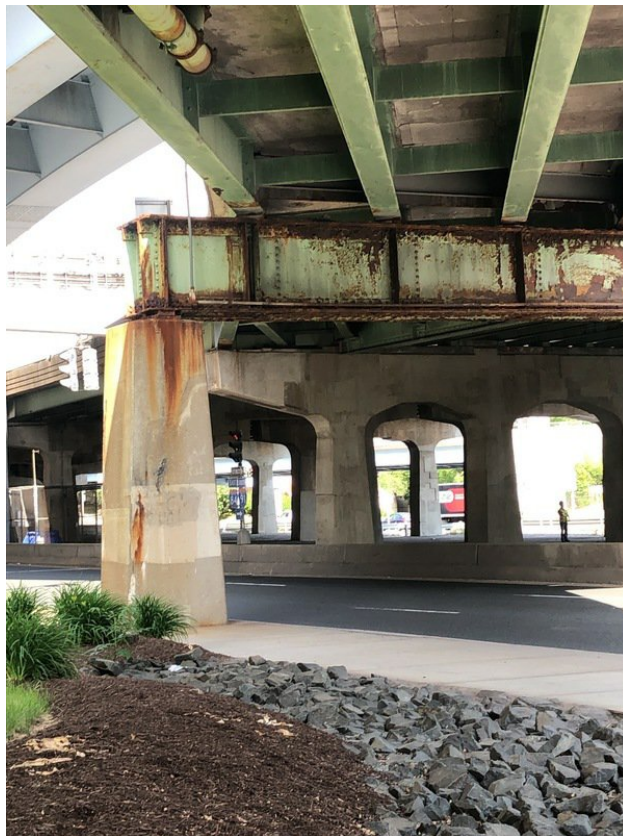
Pier 1 with I-beam where the first TCLP was sampled. This I-beam is ~200 sq ft.

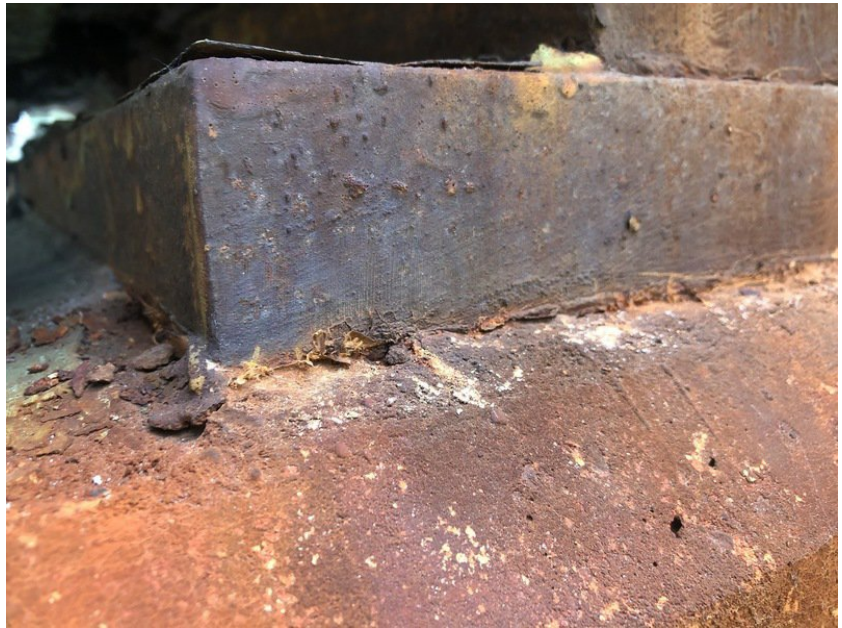
Under bearing plate on pier 1

Sample No.	Color	Homogenous	Multi-Layered	Layer No.	Other Matrix Materials	Asbestos %	Asbestos Type
1	Brown (canvas)	Yes	No	--	---	ND	None
2	Brown (canvas)	Yes	No	--	---	ND	None
3	Black (expansion joint)	Yes	No	--	20% cellulose	5%	Chrysotile
4	--	--	--	--	--	NA/PS	--

Sampled or Assumed?	Sampled
Material Acronym	C, 1
Material Description	Canvas-like caulk between bearing plate and concrete pier
Is Material a Non-Friable Organically Bound (NOB)	Yes
Homogeneous Area	Underneath bearing plates on piers
Total Approximate Quantity	~64 sq ft
Total Count	(2)
Total Count (number only)	2

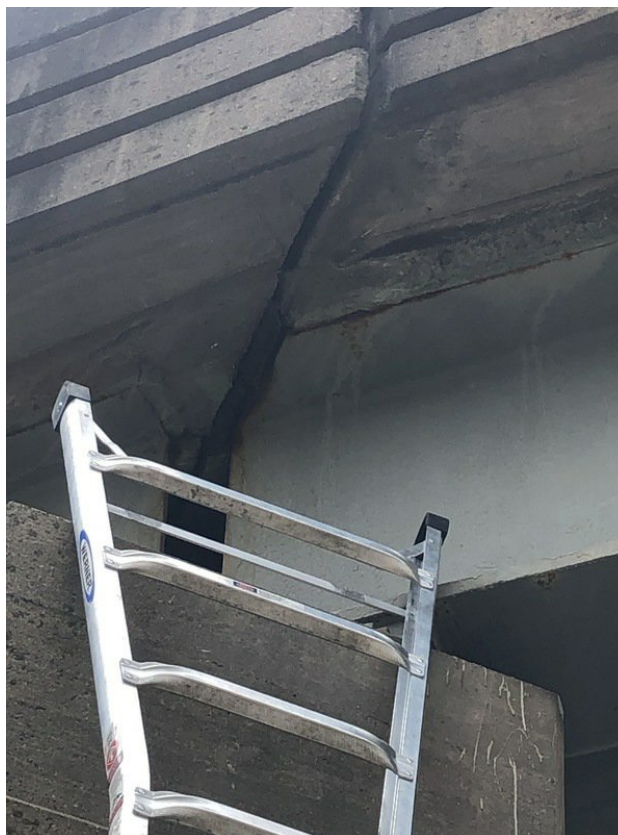
Next to pier 3 in expansion joint

Sampled or Assumed?	Sampled
Material Acronym	T1
Material Description	Black tar in expansion joint
Is Material a Non-Friable Organically Bound (NOB)	Yes
Homogeneous Area	Between all expansion joints
Total Approximate Quantity	~800 sq ft
Total Count	(2)
Total Count (number only)	2

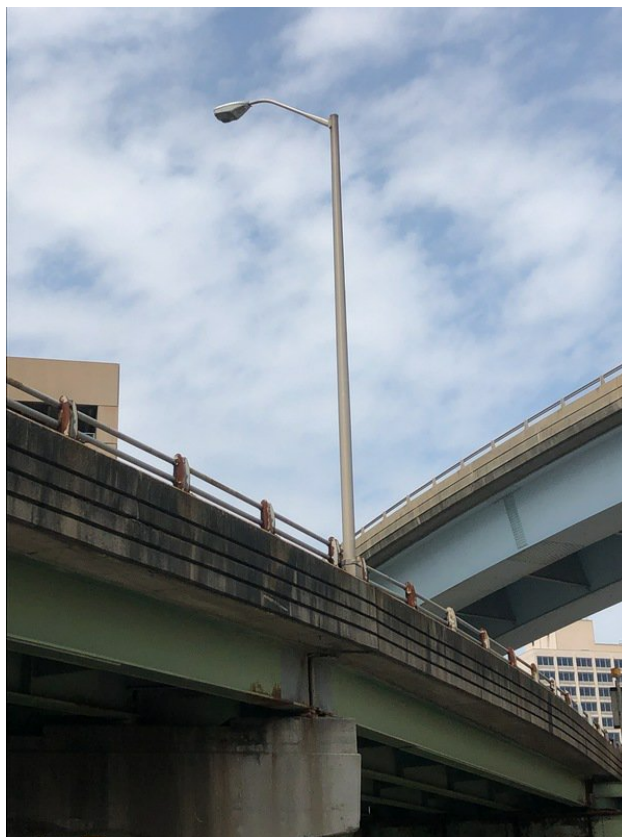
Description	Universal Waste (UW), Roadway lights
Quantity	4

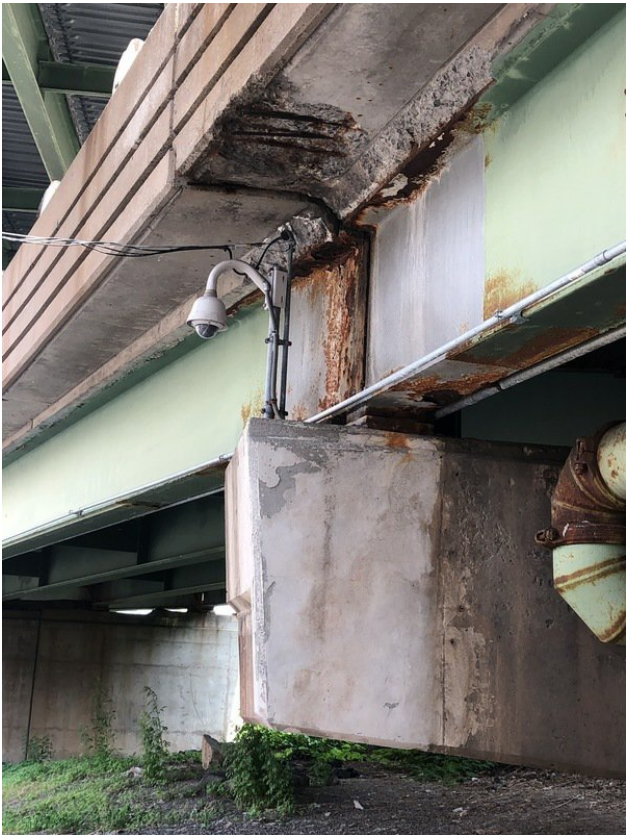
Description	Universal Waste (UW), Security System/Control Panels (Circuit boards/Hg Lamps/Batteries)
Common Name	Security Cameras
Quantity	14

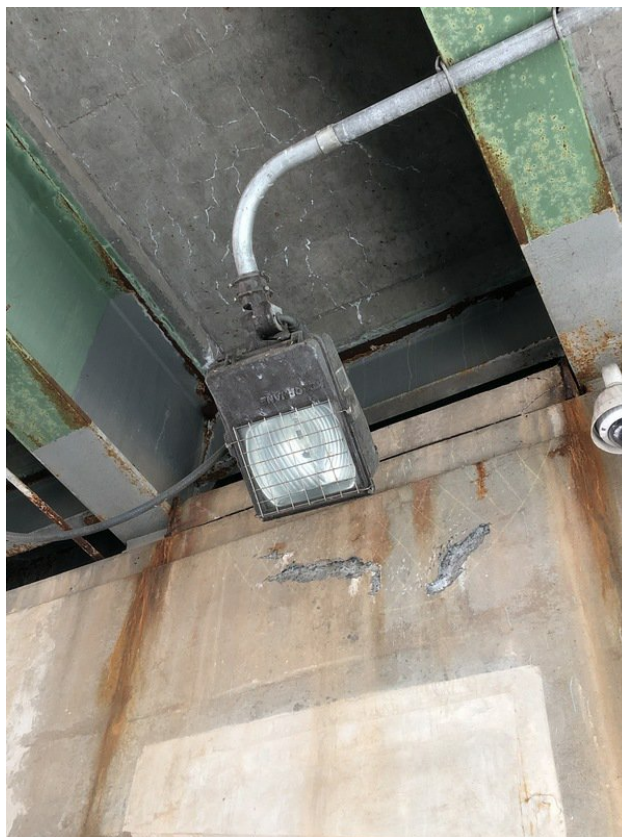
Description	Universal Waste (UW), Halogen Lights (Hg Lamps)
Quantity	10

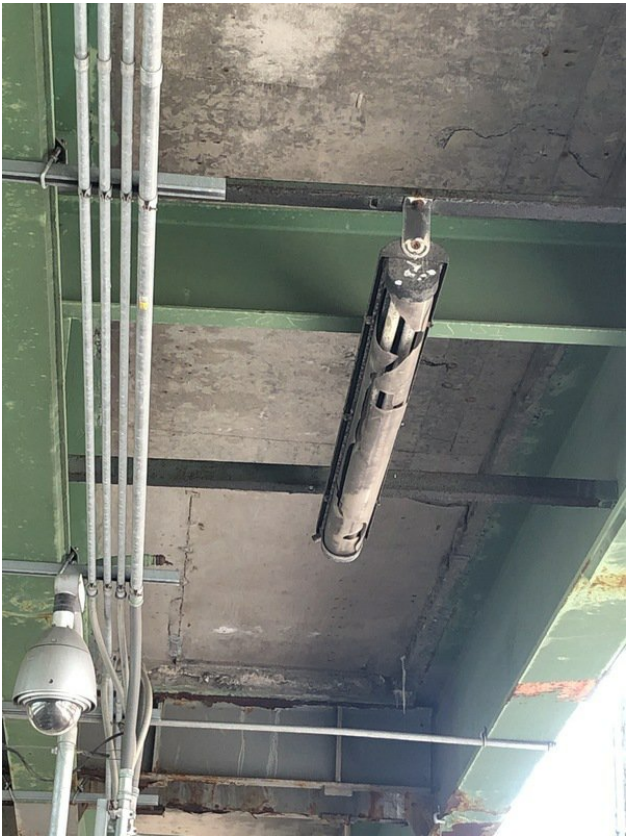
Description	Universal Waste (UW), Fluorescent bulbs - 4' (Hg Lamps)
Quantity	2

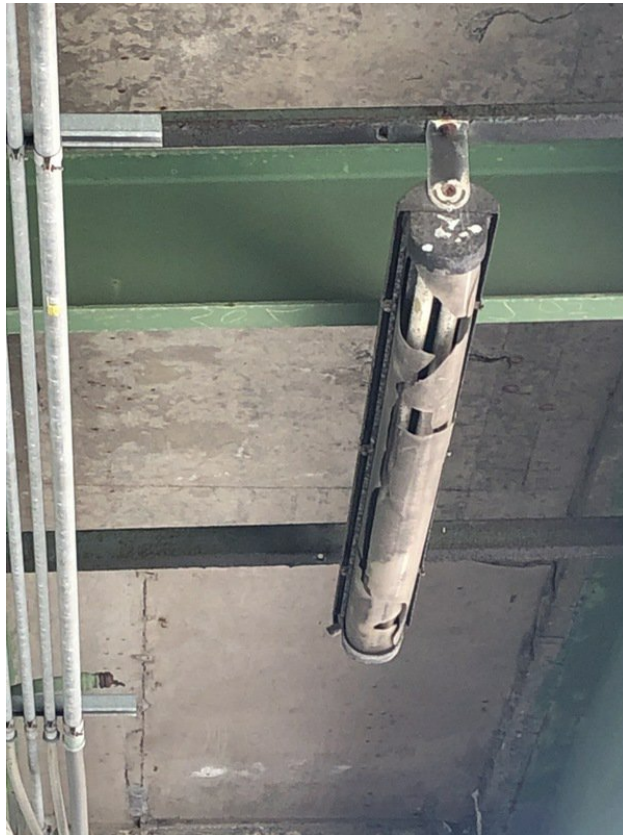
Description	Universal Waste (UW), Electronic Light Ballasts (Circuit Boards)
Quantity	1

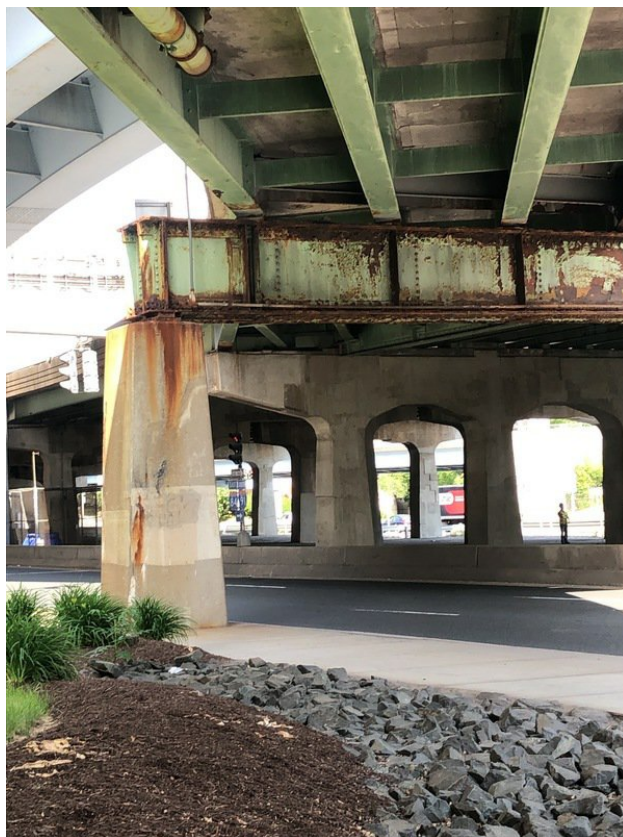
Laboratory ID	Client Sample ID	Result	RL	Units	Dilution	Batch	Prepared	Date/Time Analyzed	Notes
0060339-01	1	210	0.013	mg/L	1	B0F1234	06/12/2020	06/12/2020 13:32	
0060339-02	2	210	0.013	mg/L	1	B0F1234	06/12/2020	06/12/2020 13:37	
0060339-03	3	110	0.013	mg/L	1	B0F1234	06/12/2020	06/12/2020 13:41

TCLP/SPLP/Total Lead Sample Description	I-beam on pier 1
Metal	
Material	Metal
Square Footage	200
Type of Analysis	TCLP Lead
Grab or Composite	Grab
Date	2020-06-10
Time	09:50

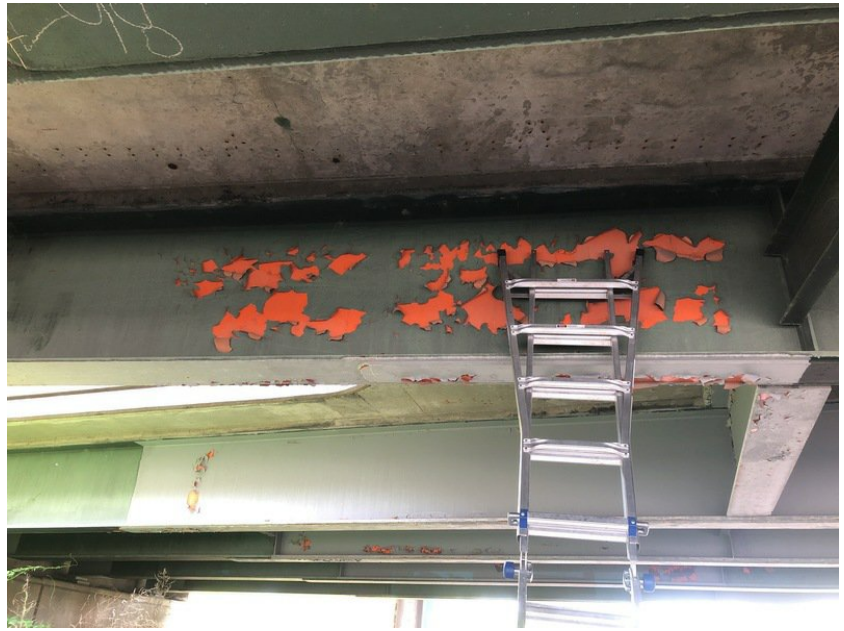
I-beam between piers 5 and 6

Material	Metal
Type of Analysis	TCLP Lead
Grab or Composite	Grab
Date	2020-06-10
Time	11:32
